24 Sussex Drive

Residence of the Prime Minister of Canada

Fall 1998

Life Cycle Management Program

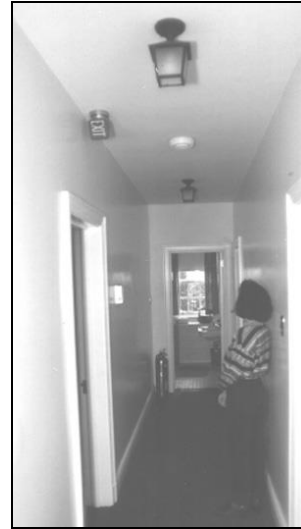
- Currently in the case of a power outage, there is only minimal battery pack emergency lighting (much of the building is in total darkness without emergency power). This is of particular concern because many of the egress routes are convoluted and full of obstacles (steps, equipment, and furniture).
- Currently, in the case of a power outage the existing passenger elevator freezes in position. This represents a life safety hazard.
- Currently there is no emergency power to the existing fire detection system.

In case of outage there is only minimal battery pack lighting.

- Provide an emergency power source sized to meet or exceed the power and distribution requirements of all site users to permit 100% back-up power. ensure the new emergency power source is wired to new emergency lighting, elevator, fire detection and fire suppression systems.

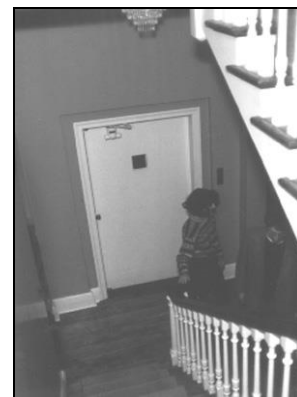
- The passenger elevator opens into the West stair. Given this stair is a primary means of egress, this is not permitted by Code. Furthermore, the elevator and its mechanical room were laid out 47 years ago and do not meet current Code CAN/CSA-B44-94.

Elevator door opens into stair

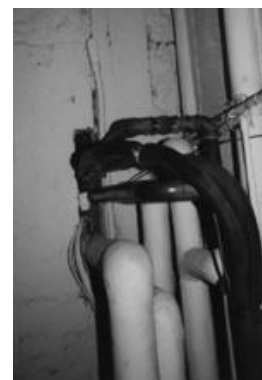
- Both asbestos and lead are present throughout the building.
- Lead is likely to be encountered in most of the older interior paint finishes.
- Asbestos is likely to be encountered as follows:
 - a) Within the insulating-wrap around hot water piping;
 - b) Within the plaster of plaster-on-lathe assemblies;
 - c) (Possibly) within some wallboard assemblies;
 - d) Within the roof assembly, as specified in 1949 renovation documents.

Asbestos and lead should as much as possible be removed

- Avoid undertaking construction work on heating system and demolition of interior finishes while the building is occupied (to minimise the risk of occupants and users being exposed to environmental hazards).
- Undertake a comprehensive asbestos audit to gain a clear understanding of where asbestos is and is not to be expected at this site.
- Unless proven otherwise, presume that plaster and pipewrap contains asbestos.
- Unless proven otherwise, presume all paint finishes contain lead.

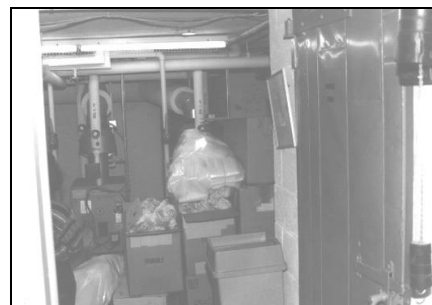
- The existing fire doors and firewalls do not sufficiently isolate the basement boiler room from adjoining areas.
- Some doors critical to proper fire compartmentalisation remain wedged open for operational efficiency reasons, elevating the risk of fire spread.
- Egress routes through the basement are cluttered with hospitality storage that no longer fits within the limited space available to occupants for storage.

Egress routes through the basement are cluttered with hospitality storage.

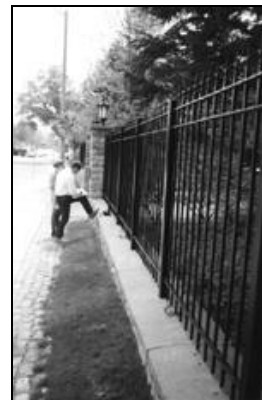
Front fence and gates are at end of useful life and need to be replaced.

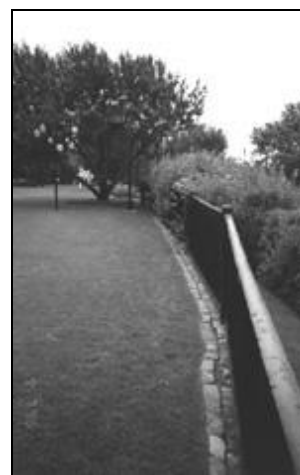
- The 1960's back fence at the top of the riverside escarpment is deteriorated to the point that it is now a safety issue.
- Retaining walls at both the escarpment staircase and the 10 Sussex parking zone are severely deteriorated and in urgent need of repair.

Rebuild the fence at the top of the escarpment.

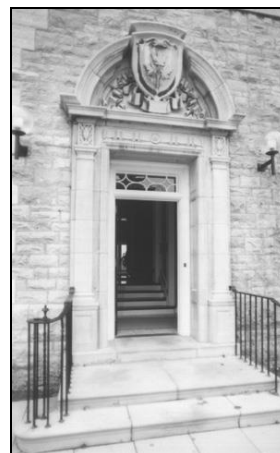
- Currently none of the entrances to the Residence are universally accessible
- There is a passenger elevator (1950-installed) in the south stair core; however it does not meet minimal accessibility requirements for cab size and accessories design.
- On any given floor there are level changes that represent obstacles.
- Currently there is no elevator access to the third floor.
- Currently there are no universally accessible bedroom or bathroom facilities in the Residence.
- Currently the furniture layout in some State Areas is too tight to meet U.A. standards for persons in wheelchairs.
- The current fire alarm bell system does not meet standards for the hearing impaired.
- Curbs and steps are a reoccurring obstacle throughout the grounds; none of them are wheelchair accessible.

Front entrance must be universally accessible.

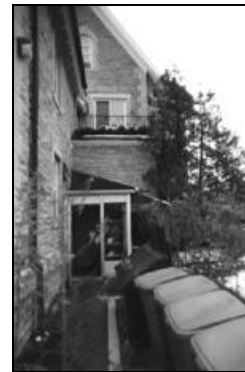
- The service area outside the back door disrupts circulation routes and is visible from inside the home.
- Many significant trees and plantings and landscape elements are either attaining maturity or reaching the end of their life cycle.
- Some existing landscape materials (e.g. paving materials) and fixtures (e.g. lampposts) need to be reviewed for heritage appropriateness to this context.

Better treatment of the service area is required.

- Significant and heritage landscape elements such as the "old growth forest" on the escarpment must be clearly identified.
- Better treatment of the service area is required.
- Replace landscape elements, where necessary, to better integrate with the character of the site.
- A hierarchy of materials should be established, especially with walkway surfaces (entertaining areas vs. service areas).
- Heritage landscape issues should be incorporated into the Site development plan (see Grounds section).

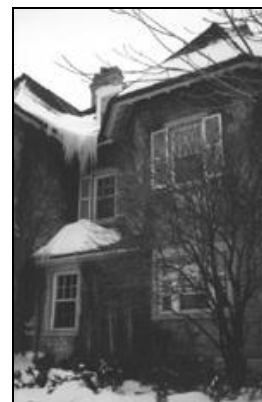
- The exterior walls are not insulated and the windows have deteriorated to the point there is excessive air infiltration; this causes elevated energy use, elevated heat loss, and imbalanced air-quality and airflow.

Insufficient insulation causes energy loss.

- Energy loss engineering studies should be carried out to establish ways to reduce energy use, air infiltration and HVAC type problems.
- A study should be done to establish the cost and effect of insulating the exterior walls.
- The windows should be restored to achieve weather tightness (see Guideline C03).
- The NCC should continue to conduct environmental impact assessment screenings of its construction projects.
- The NCC should review its maintenance practices to establish the nature and potential of environmental impact.

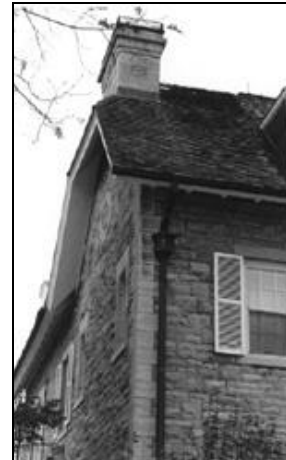
The eavestroughs and downpipes need to be replaced.

- Replace the existing copper eavestroughs and downpipes system ‘in kind’ when undertaking replacement of the roofing system.
- In preparing design documentation for replacement of copper eavestroughs and downpipes system, consider using heavier copper gauge materials, and installing heating cables within those stretches of eavestroughs and downpipes most prone to blockage by ice / snow.

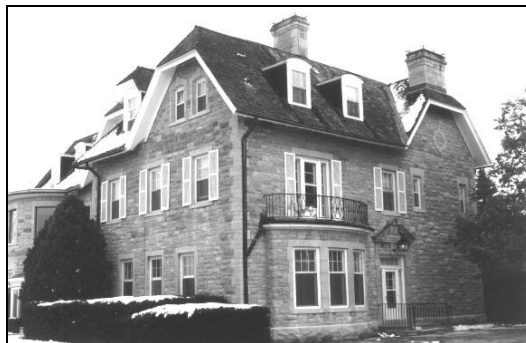
- Most of the existing 'outer' (storm) windows date from the 1970's. They are aluminium storm windows, c/w insect screens. Though functional, they detract from the heritage character of the building. Furthermore, because of their high thinwall frames, the 'outer' (storm) windows create significant shadow within the window.
- Most of the existing 'inner' windows date from the 1951 renovation or before. They are excellently detailed and built, and are of robust, handsome proportions. Though these 'inner' windows suffer from flaked putty and peeling paint, the windows are excellent candidates for re-weatherstripping. To the inner face of the 'inner' window an additional pane of glass has been added.
- The condition of the sunporch windows is generally poor with respect to heat loss, infiltration, and ease of operation.

Windows in a building are major determinants of a building's character. They should be restored where deterioration has occurred.

- Remove the 'outer' (storm) windows, replacing them with white-painted wood screens and storms.
- Restore the 'inner' windows to ensure they are in top working order. When undertaking the restoration work, add new interlock weatherstripping to eliminate air leakage.
- To assist Interior Services in protecting artwork, furnishings and fabric from ultra violet and infrared light damage, it is recommended that argon filled sealed units be specified when windows require replacement.
- If the sunporch is not rebuilt (see C07), the existing windows should be replaced by new windows of an energy efficient design that augments the heritage character of the site.
- Replace all four family room windows with double-glazed white-painted wood windows, designed to be sympathetic to the building's heritage character yet offering sufficiently expansive views towards the north.

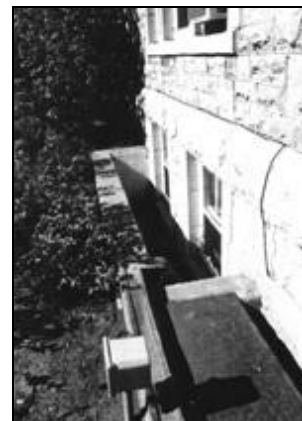
- The foundations are of stone masonry and sit directly on rock. Though the main residence is at a high point in the landscape, there is a marginal risk of localised ground-water problems; there is no evidence of existing perimeter drains (to evacuate groundwater from the foundations) nor of any in-ground piping systems (to evacuate water brought down from the eavestroughs / downpipes). Bedrock is typically close to the surface at this site so the foundations are not beyond frost penetration.

There is no evidence of existing perimeter drains to evacuate groundwater from the foundations.

- Monitor the basement for evidence of infiltration; if flooding becomes a problem, install drainage system.
- Position and direct the gardener's irrigation sprinklers as far as possible away from the building.

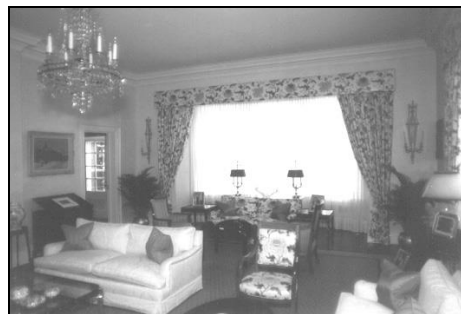
- In a house of this stature, there should be centralised heating and cooling systems, fully adjustable in each room to maintain relative humidity and temperature conditions that meet the occupant's preferred comfort levels.
- Because artwork, furnishings and fabric are affected by heating and cooling systems that fluctuate, temperatures and humidity levels should be maintained as constant as possible.
- Should there be a conflict between the comfort level requested by the occupants and the ideal condition sought for the property contents, the former will have priority. In such cases, there shall be a case for substitution of fragile Crown Collection artwork and furnishings.

There is no centrally operated air-conditioning system, only individual A/C units mounted in the windows.

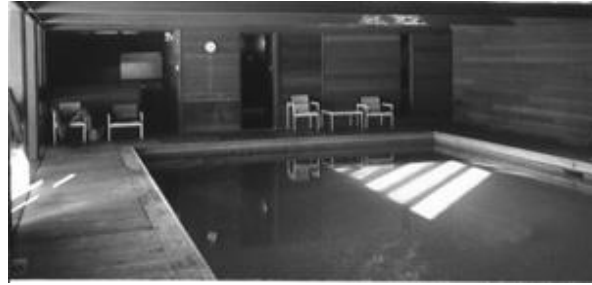
- The existing pumps and filter systems are nearing the end of their useful life and should be replaced.

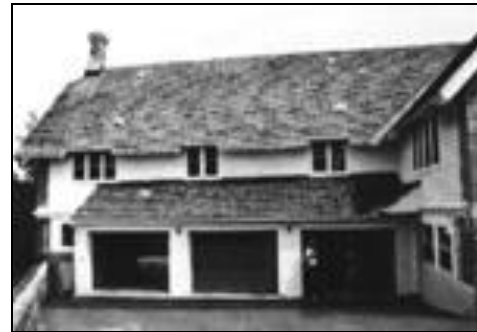
- The windows at this outbuilding are of solid construction, but suffer from significant deterioration.
- The existing garage doors are of deteriorated condition, and lack current safety devices.

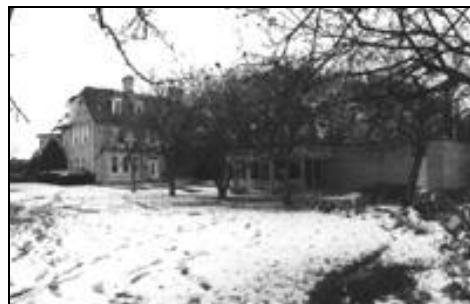
Some trees are at the end of their life cycle.

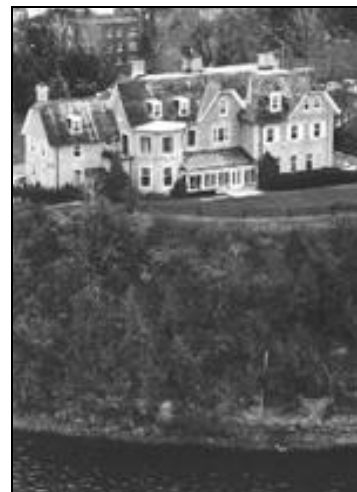
- Most of the site drains toward Sussex Drive; the balance drains towards the river side escarpment. In some of the locations where water drains over the escarpment, lack of vegetative cover, uncontrolled surface drainage and inappropriately configured culverts are causing considerable erosion.
- With the installation of the RCMP security fence in 1997, a 2.0 metre wide swath of vegetation was removed, leaving a noticeable clearing that exacerbates escarpment erosion.
- River-borne debris regularly accumulates along the shoreline affecting how those touring on the Ottawa River appreciate this official residence.
- It has recently been reported that the riverside escarpment behind the residence has an old growth forest of trees up to and over 300 years old.

Escarpment is prone to erosion.

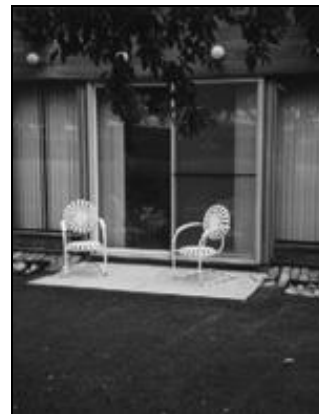
- The patio on north side of the pool building is functionally unusable; it is too small, water drains towards it and the area is constantly soggy.
- Environmental standards now require that 'storm' sewerage (e.g. groundwater, rainwater) be separated from 'sanitary' sewerage. Because new sewerage lines are normally laid deep below grade, the laying of a new 'storm' sewer at this site would necessitate trenching through major (costly) bedrock.

The patio on the north side of the pool building is functionally unusable.

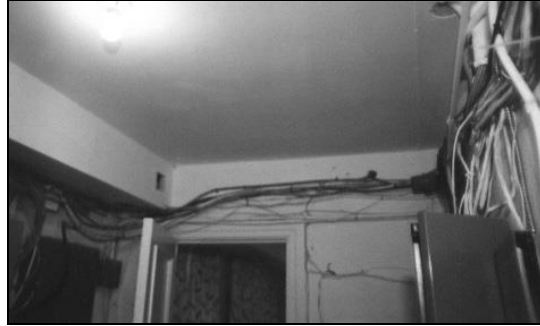
- The power distribution system was revamped in 1975 during the construction of the pool. The primary cables and transformer vault are maintained by PWGSC and are inspected at least once a year. In 1988 the 400A service was running at 78% capacity. Addition of any major new electrical load may overload it. The house is wired with RH-BX type wiring which is now over 40 years old.
- Some wires have been installed exposed along baseboards and walls; this is not suitable for the Prime Minister's residence.

The house was rewired in the 1950s; it should be rewired again.

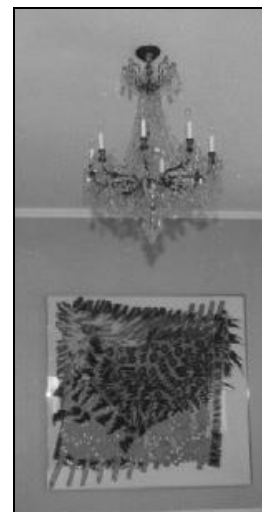
- Though the Residence is laid out in a fashion that offers most primary spaces at least one window, the proportion of window area to wall area is generally low. Significant zones of the main building suffer from inadequate natural lighting levels, relying instead on electrical lighting. Much of the current lighting system is dated and ineffective.
- Currently, some of the artwork in the Residence is exposed to excessive natural light levels, excessive electrical lighting, and/or inappropriate light types. Excessive and/or improper lighting can cause serious damage to artwork and fabrics (the items most susceptible to damage by improper light levels are works on paper).
- Currently much of the artwork in the Residence is poorly lit, reducing the art-appreciation experience.
- In service areas, there is a preponderance of ill-suited area lighting.

Works of art on display can be damaged by excessive natural light levels

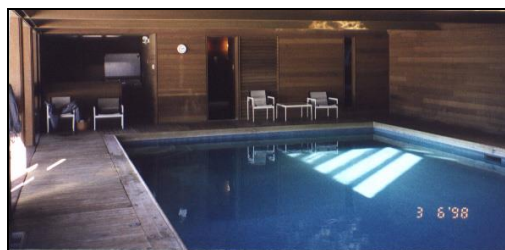
- The cedar wood interior finish of the pool is badly stained in places and requires cleaning. Various other decor elements such as floor covering and blinds also require replacement.

Pool building interior: a decor plan is required.

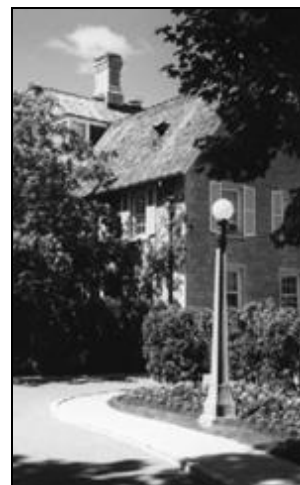
- There has never been an overall plan for exterior lighting. Changes over the last 46 years have been made in a piecemeal fashion. There is therefore a mixture of luminaire style and type.
- Some individual lighting fixtures and structures have deteriorated to the point that they need to be replaced.
- Highly inappropriate lighting affixed to the exterior of the residence (e.g. “parking garage” fixtures and exposed wiring are typical).

There has never been an overall plan for exterior lighting.

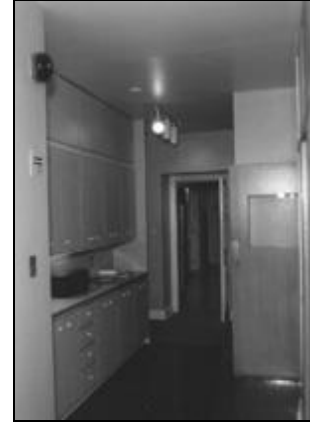
- There is only one door separating the dining room from the kitchen. During dinner:
 - a) the noise of kitchen activity often disrupts the dining room;
 - b) there is a major risk of support staff colliding head-on as personnel head in and out of dining room with trays and trolleys.
- Within the kitchen, there is major circulation problem at the servery as support staff prepare plates prior to service into the dining room; there is insufficient space available, and what there is, is laid out in a fashion that requires contrary circulation.

There is a major circulation problem at the servery.

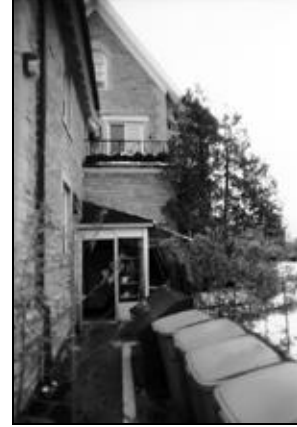
- The outdoor service area near the back door to the residence is disorganised; there is no structure to house the garbage cans and containers, nor is there adequate screening provided.

Inadequate screening for garbage containers

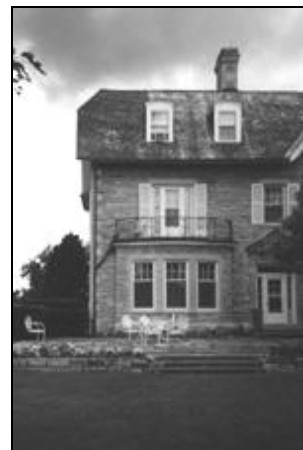
The side patio is currently not properly secluded from front of house.

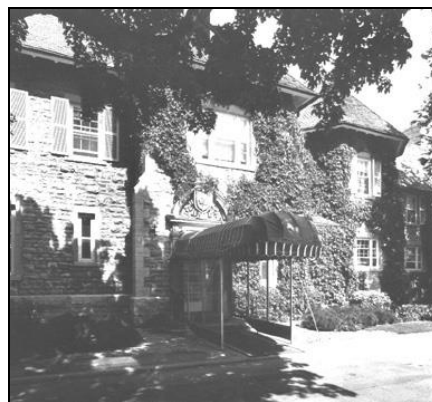
- The practice in recent years had been to rent each winter a canvas enclosure to cover between the main residence front door and the limousine drop-off point; such canvas enclosures seriously detract

A suitable winter enclosure is needed at front entrance.

from the heritage character of the facade, and are unbecoming of a Prime Minister's residence.
