24 Sussex Drive

Residence of the Prime Minister of Canada

Fall 1998

Life Cycle Management Program

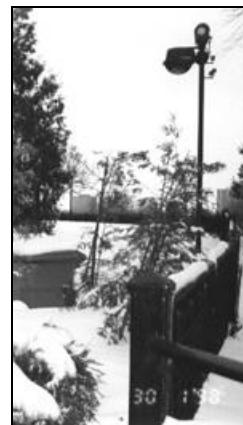
It is necessary to integrate security items with the architecture and the landscape arch.

- Any future changes to the security systems should be of minimal impact to the heritage character of the site.

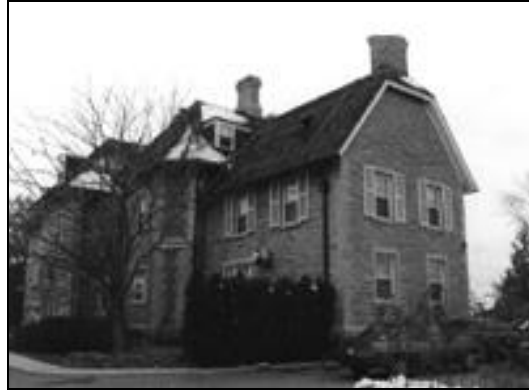
- The stonework, mortar, windows, doors, roof, chimneys, and other architectural elements are all important heritage elements, and require life cycle maintenance/careful restoration;
- Many elements which detract from the heritage value have been added to the facade (e.g. surface mounted cable television wires and power cables, modern “flood lights”, aluminium storm windows and the kitchen vent on the front facade).

Exterior forms and materials are all important heritage elements.

- It is essential the entirety of the exterior is treated as a Classified heritage building deserves, all elements not deemed historically important should be architecturally integrated;
- Relocate electrical and communication cables from facade
- If the major kitchen reorganisation recommended elsewhere within this report is declined, the existing exhaust duct should nonetheless be re-routed away from the front facade. If the major kitchen reorganisation is undertaken, the designers should ensure that the Sussex Drive facade be kept free of mechanical/electrical systems components.
- Architecturally integrate all exterior lighting attached to building, both in terms of fixtures and electrical cable routings.
- Ensure all work includes landscape reinstatement according to the Landscape Masterplan.

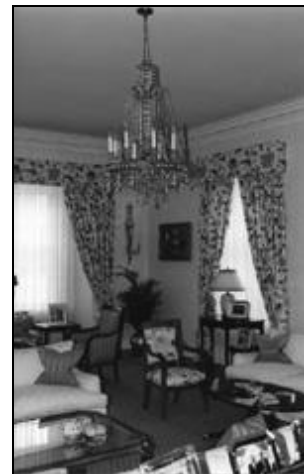
- A walk through the house currently gives a very rich feeling for the past. Since the 1951 renovation there have been very few changes to the interior other than finishes and furnishings. However, it must be recognised that the heritage value can easily be eroded by insensitive incremental changes to small components such as 1950 door hardware and lighting.
- In private quarters the radiator-covers are of an inappropriate style.
- In much of the Residence, lighting fixtures and switchplates are of inappropriate style.

A walk through the house currently gives a very rich feeling for the past.

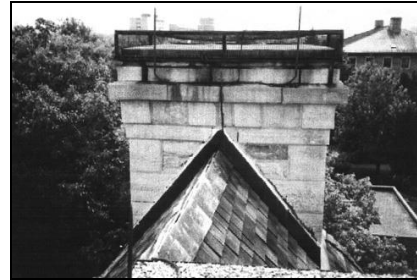
All chimneys should be kept, regardless of whether they're for functioning or non-functioning fireplaces.

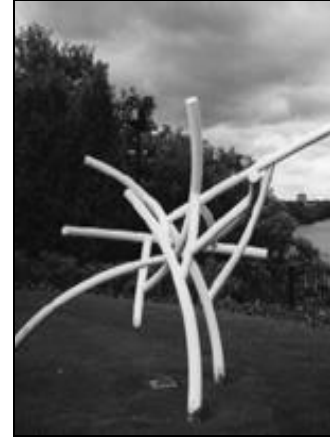
Exterior art needs to be planned.

- Consideration should be given to establishing a multi-year maintenance schedule and funding forecast for exterior art repair and restoration. Professionals in this field should carry out restoration work.
- Incorporate into the 24 Sussex Dr. Site development plan a site 'capacity' for installation of donations. Have a procedure in place for the acceptance and locating of exterior art and gifts for the site.

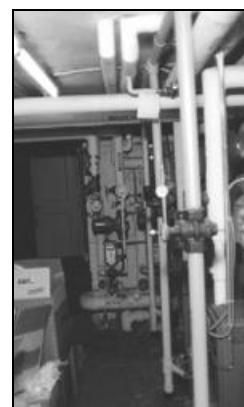
Gas fired hot water heating.

- A study for alternative emergency sources of heat should be undertaken.

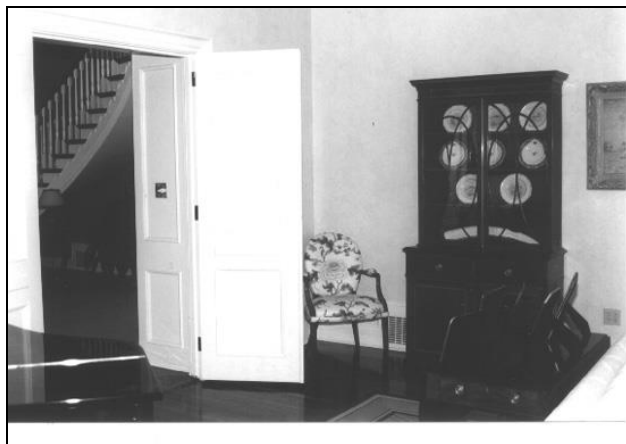
New Interior Services plans are required for all state rooms.
